Manhole Inspection Summary

Manhole # S25CC1023MH

Location Address: **3678 CAIRNES LN**

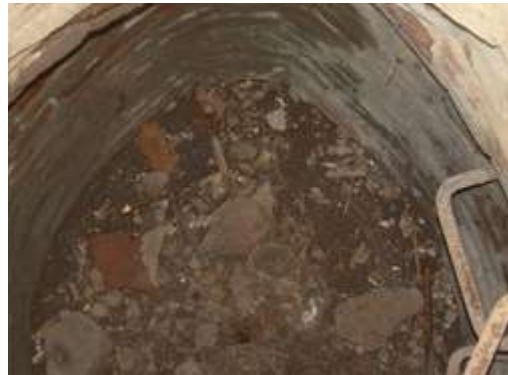
Top View

Channel debris.

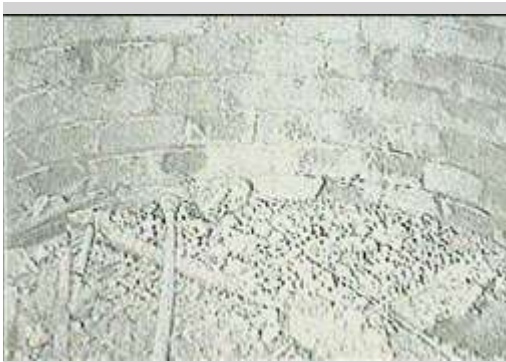
Defect

Barrel deterioration and infiltration. Bench debris.

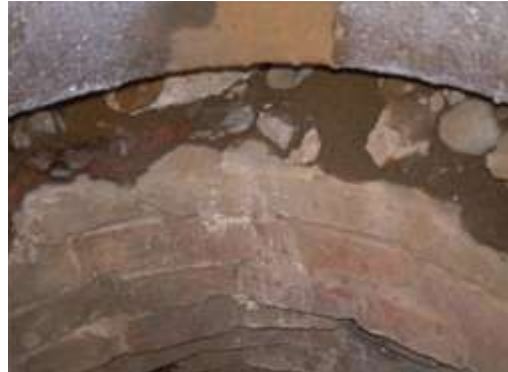
Defect

Frame leaks. Adjustment deterioration and infiltration.

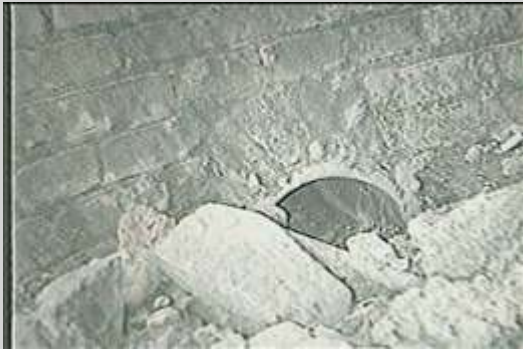
8 in. Circular Gravity Sewer
Pipe Out @ 12 O'Clock

Deposits: ☐ None ☐ Mud ☐ Sludge ☒ **Debris** ☐ Grease

Silt Depth: **3** (in.) Deposits Extent: **Medium**
